Subject: September 17, 2013 Compliance Evaluation Inspection

**CWA COMPLIANCE EVALUATION INSPECTION REPORT**  
**U.S. ENVIRONMENTAL PROTECTION AGENCY, REGION 5**

FOIA Ex. 6 [REDACTED] Land and Cattle, LLC

ILA010071

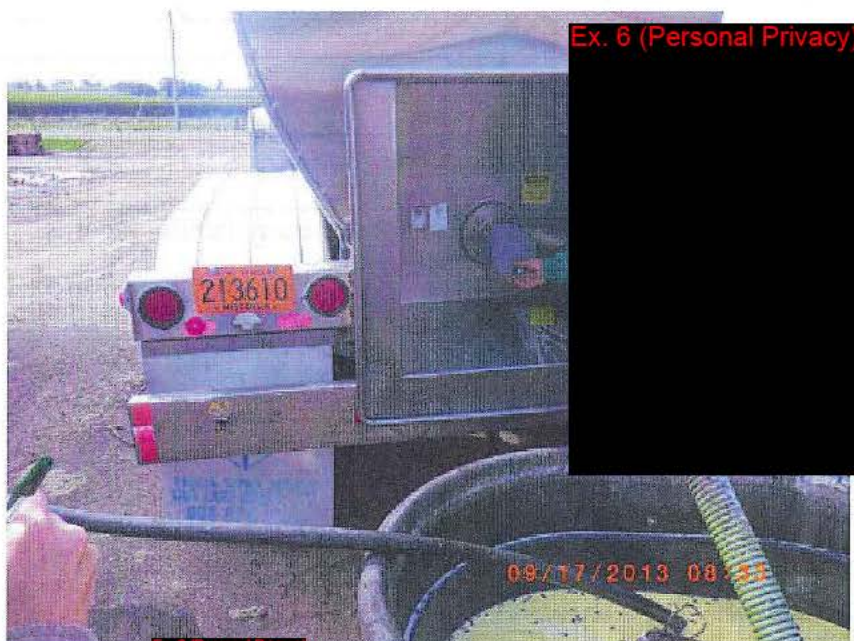
IMGP0212 [REDACTED] constructed a cap for the pipe connection that can be locked with a padlock to prevent unauthorized release of DLP from the tanker truck.

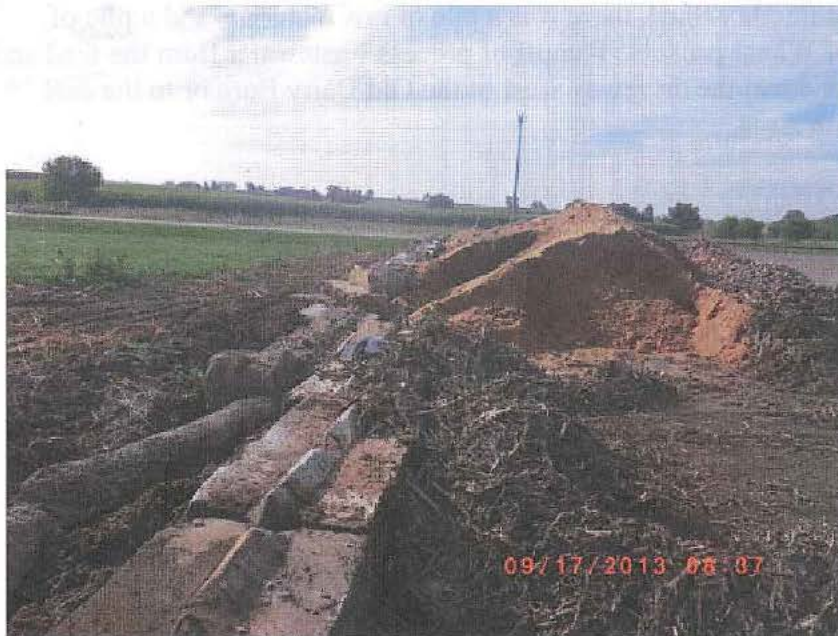
IMGP0217: Concrete blocks had been placed on the east side of the mixing area to prevent runoff to the intermittent unnamed tributary. Agricultural lime was placed on the west side of the blocks and dirt on the east side. The blocks were moved in preparation for the concrete delivery. Feed is temporarily stored here while the South Commodity Shed pad was being poured.

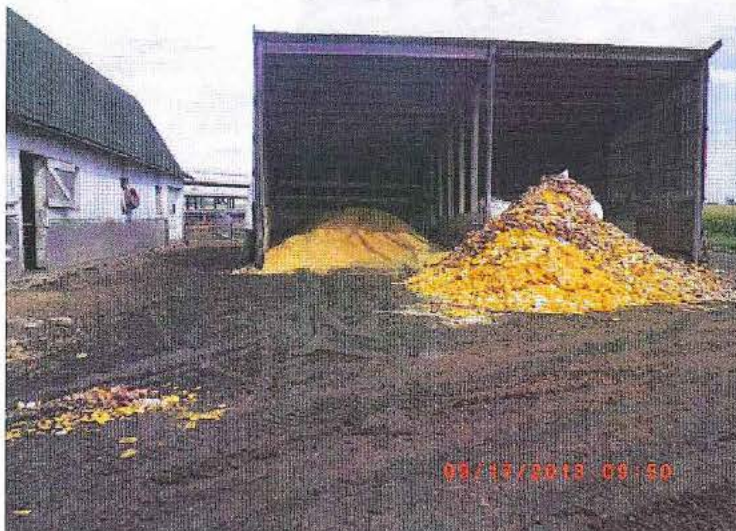
In front of the North Commodity Shed, there was a pile of raw materials and a pile of taco shells and Cream of Wheat packets. Runoff of process wastewater from the feed and raw materials could flow down the driveway west of the Old Dairy Barn or to the east and to the Cattle Working Area.

IMGP0220: North Commodity Shed has a pile of taco shells and Cream of Wheat packets out in the open. Runoff from this area could flow with precipitation either down the driveway west of the Old Dairy Barn or to the east and through the Cattle Working Area.  
Location: North of Old Dairy Barn  
Facing: North  
Date/Time: 09/17/13 10:50 A.M.

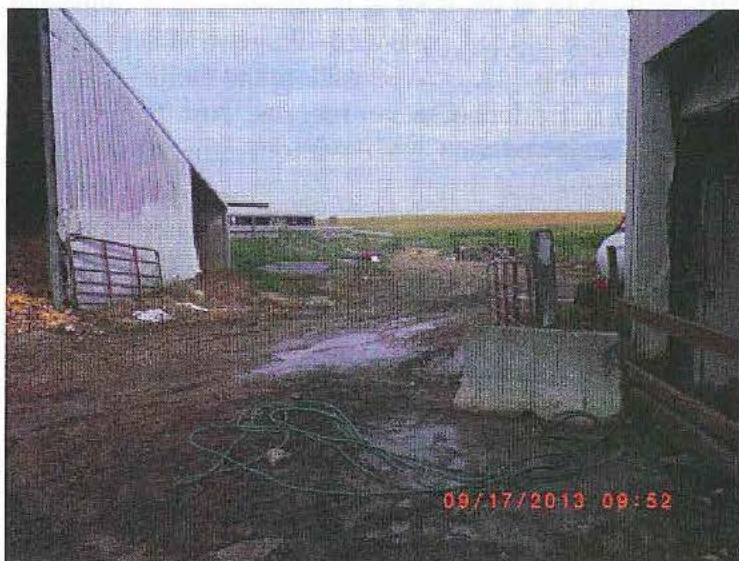
IMGP0222: Precipitation pathway from the North Commodity Shed to the east.  
Location: North of Old Dairy Barn  
Facing: North  
Date/Time: 09/17/13 10:52 A.M.

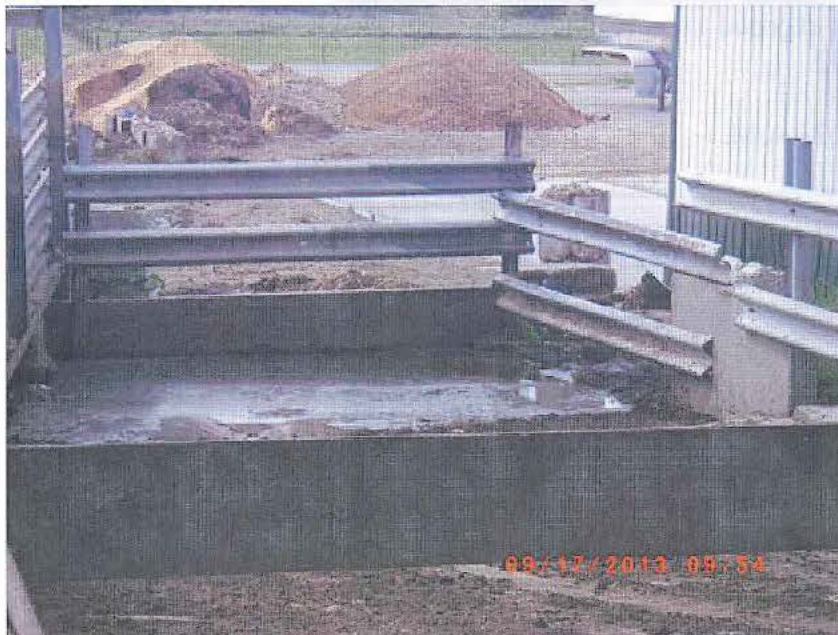
joined EPA and IEPA and explained that precipitation that falls on the roof of Barn #1 and on the Cattle Working Area would flow out at that location. From there it would flow to the vegetated area to the east of the concrete pad for the southern commodity shed. The intermittent unnamed tributary of Cedar Creek is approximately 275 feet to the southeast of the relief point in the wall of the Cattle Working Area.

stated that it would be very difficult to scrape the Cattle Working Area because the concrete floor was cracked.

IMGP0229: Southwest corner of the Cattle Working Area where manure and process wastewater are not contained.

1. Manure and process wastewater could flow out of the Cattle Working Area at the southwest corner to the vegetated area and then to the intermittent unnamed tributary of Cedar Creek. The intermittent unnamed tributary is approximately 150 feet to the southwest.
2. Process wastewater from the mortalities that were placed on the bank of the intermittent unnamed tributary would flow to the tributary.
3. The berm of the Manure Storage Pond was being eroded from the flow of manure being pumped to the pond from the under barn pits.
4. The vegetation on the berm of the Manure Storage Pond was not mowed and there were holes from burrowing animals in the berm.

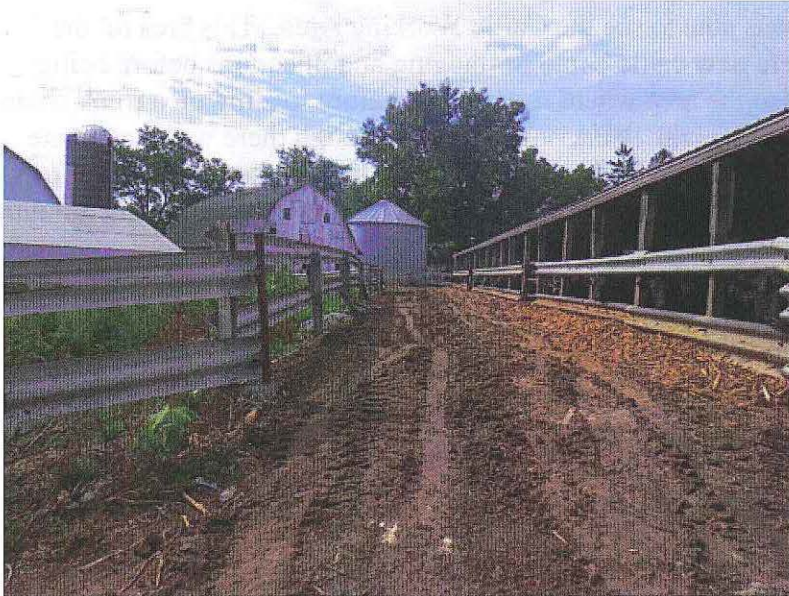
IMGP0236: Feed lane is exposed to precipitation for Barn #2.

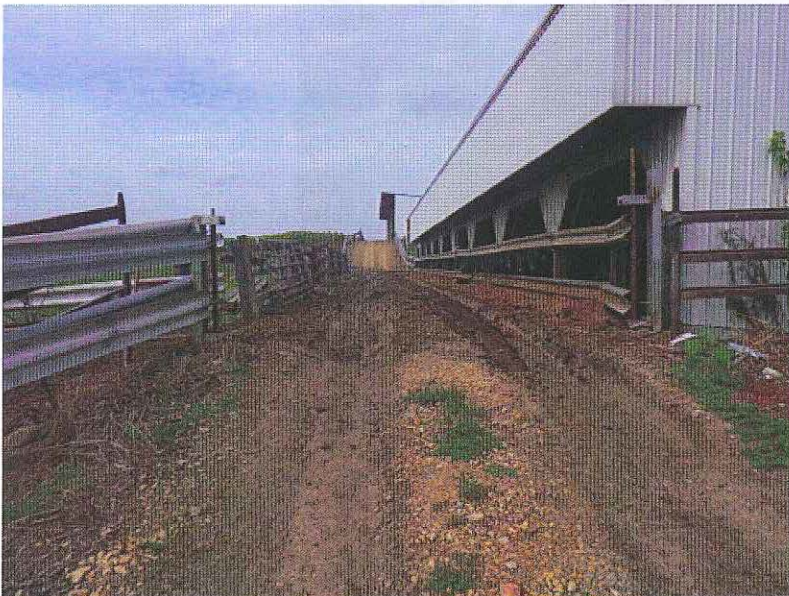
IMGP0240: South side of Barn #3. Feed in feed lane is kept under roof overhang.

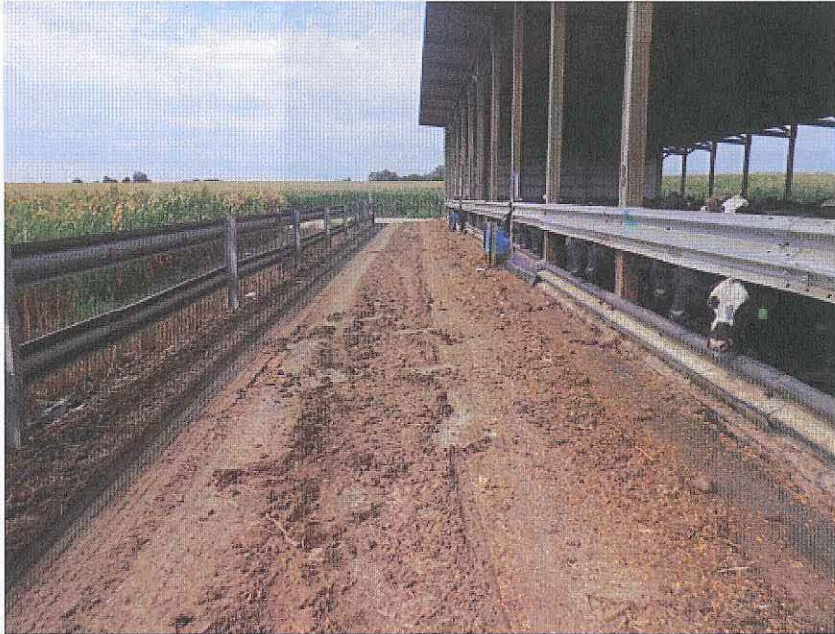
IMGP0244: South side of Barn #4. This barn has a ten foot pit that is pumped out and directly land applied twice per year. The feed is covered somewhat by an overhang of the roof.

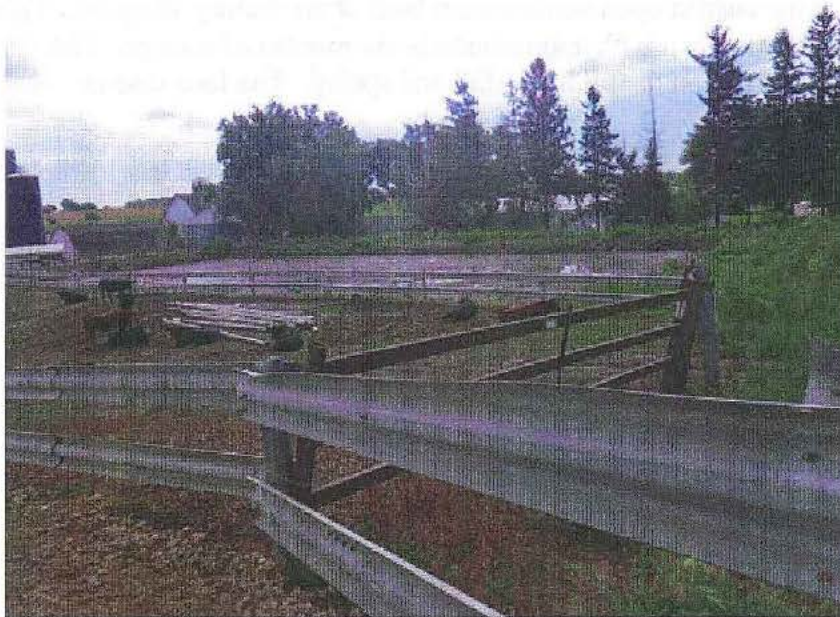
IMGP0243: Injured animals are confined in the space north and east of the Manure Storage Pond. They are also able to access an area south of the Manure Storage Pond.

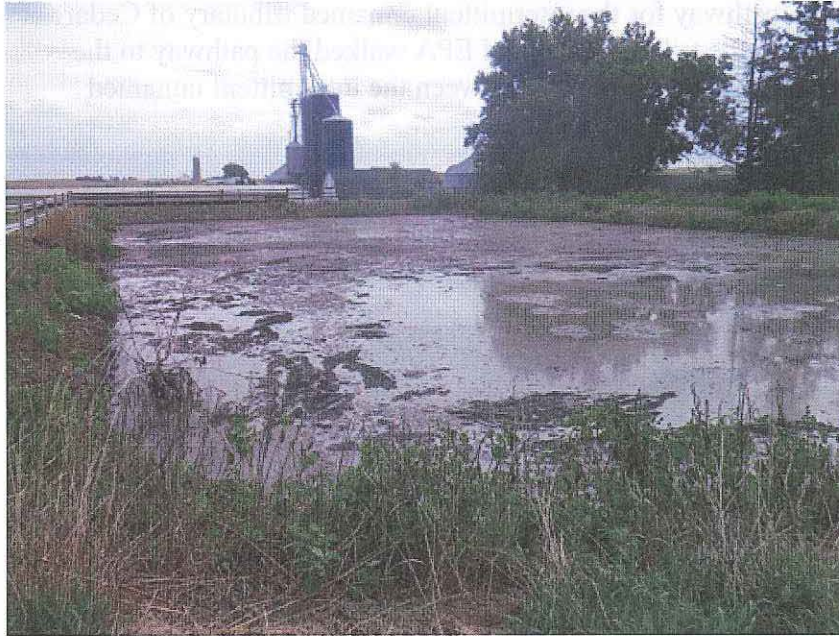
IMGP0245: The Manure Storage Pond appeared to have about four feet of freeboard.  
 Location: Northwest corner of the Manure Storage Pond  
 Facing: Southeast  
 Date/Time: 09/17/13 11:37 A.M.

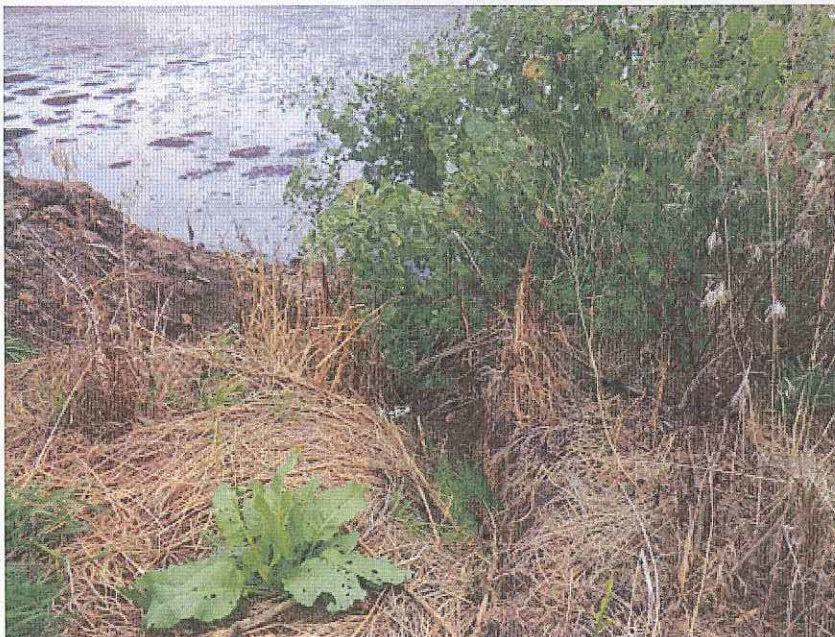
EPA walked around the berm of the Manure Storage Pond. In the locations where the manure was pumped to the pond, the berm had been eroded and there were gouges in the berm wall. EPA also noted a couple of burrowing animal holes. The vegetation on the berm was not kept short and EPA estimated that there was approximately four feet of freeboard in the pond. The depth marker was located on the north side of the pond.

IMGP0247: Erosional feature from where hosing is laid when manure is pumped to the Manure Storage Pond.  
 Location: Southeast corner of the Manure Storage Pond  
 Facing: Northwest and down  
 Date/Time: 09/17/13 11:39 A.M.

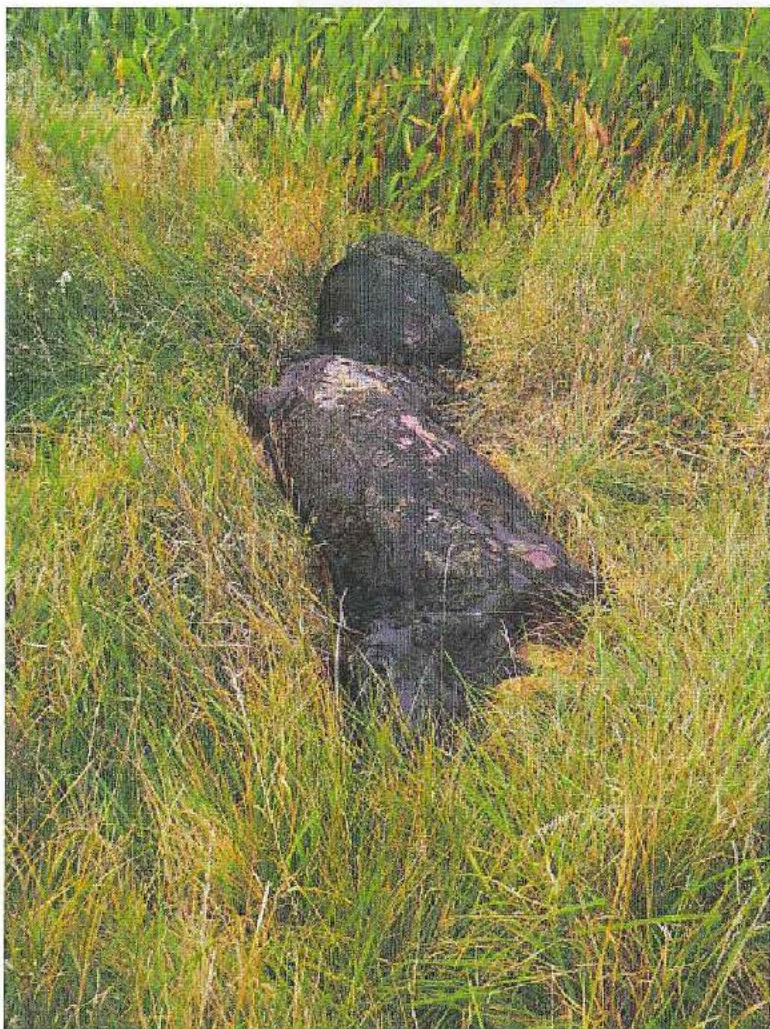
At the southeastern corner of the corn field, EPA observed two dead cattle that had been placed on the bank of the waterway. The cattle were in an advanced state of decomposition and there were pools of maggots around the carcasses.

IMGP0251: EPA walked down the (dry) intermittent unnamed tributary from east of Barn #2 to Cedar Creek. Southeast of Barn #1, EPA observed two dead cattle lying on the bank of the tributary.

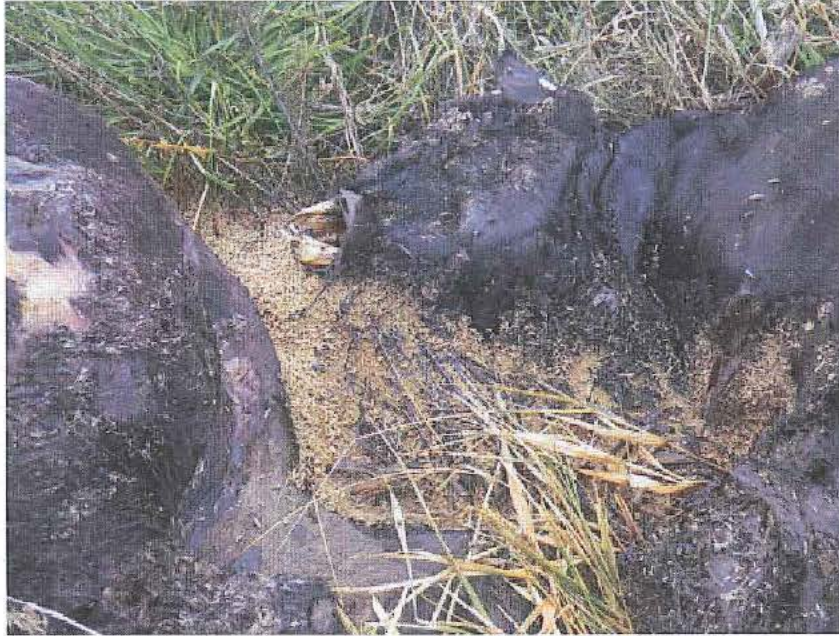
IMGP0253: Mortalities were covered with maggots.
